Contract #: 04-0120F4Cty: SF/ALA Rte: 80 PM: 13.2/13.9File #: 69.28**WELDING INSPECTION REPORT****Resident Engineer:**Pursell, Gary**Address:** 333 Burma Road**City:** Oakland, CA 94607**Report No:** WIR-000488**Date Inspected:** 21-Sep-2007**Project Name:** SAS Superstructure**OSM Arrival Time:** 2330**Prime Contractor:** American Bridge/Fluor Enterprises, a JV**OSM Departure Time:** 800**Contractor:** Zhenhua Port Machinery Company, Ltd (ZPMC), Changxing Island **Location:** Shanghai, China

**Bridge No:** 34-0006**Component:** Caltrans Mock-Up**Summary of Items Observed:**

Caltrans Quality Assurance (QA) Inspector, Mike Hasler was present to observe the fitup, welding and related activities associated with the fabricating of Caltrans Mock-up, 77M, 89M and 114M, for the San Francisco Oakland Bay Self Anchored Suspension Bridge, at Zhenhua Port Machinery Company (ZPMC) facility on Changxing Island.

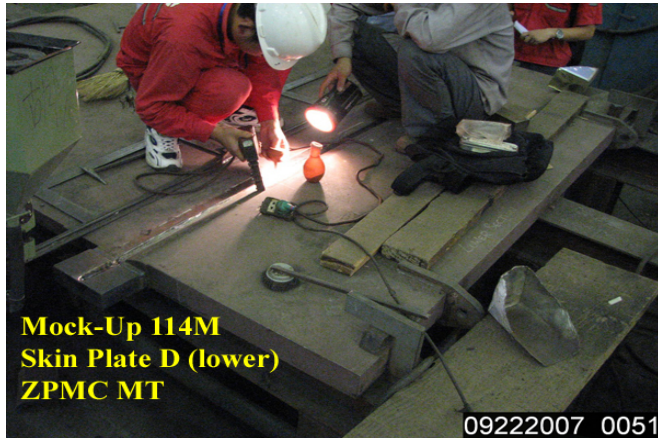
Mock-Up 114M, Skin Plate D (lower section): Caltrans QA Inspector observed submerged arc welding (SAW) in progress at skin plate splice weld number 1, piecemark mp1016 to MA110. The welder operator is observed welding a partial joint penetration (PJP) root pass weld in the flat position. Welder is identified as Mr. Han Changhou. The welder is using welding procedure specification WPS-B-T-2321-B-P3-S-1, Revision 1. Caltrans QA Inspector measured current welding parameters at approximately 550 amps, 31.5 volts and travel speed, 460 millimeters per minute (mm/min). Preheat and interpass temperatures were verified during welding activities. Preheat temperature prior to the start of welding measures more than 110 degrees Celsius (230 degree Fahrenheit) but less than 232 degrees Celsius (450 degrees Fahrenheit) during maximum interpass temperature verification. SAW consumables were verified and identified as JW-3, classification EM12K, diameter 4.8 mm (.189 inches) electrode and JF-B Flux, classification F7A2. Caltrans QA Inspector witnessed ZPMC QC non-destructive testing technician, Mr. Cai Xin xin perform magnetic particle test (MT) and Visual Test (VT) inspection of the root pass weld. The MT test appeared to be in general conformance with AWS D1.5 2002 requirements and no relevant indications observed. Caltrans QA Inspector performed MT and VT inspection of the root pass weld. See Caltrans Magnetic Particle Test Report, TL6028, generated on this date for additional information. The following digital pictures illustrate ZPMC MT in progress.

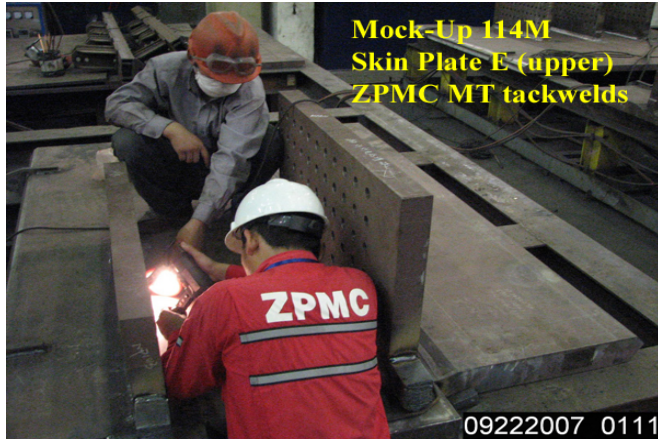
- Mock-Up 114M, Skin Plate E (upper & lower section): Caltrans QA Inspector witnessed ZPMC QC nondestructive (NDT) technician, Mr. Cai Xin Xin perform magnetic particle test (MT) and Visual Test (VT) inspection of the partial joint penetration root pass tack-welds, weld number 1, 2, 4 & 7, upper assembly section, stiffener plate to skin plate and the lower assembly, root pass weld, identified as weld 7 and 8. ZPMC MT and VT coverage consisted of one-hundred percent of the tack-welds and root pass welds. MT test appeared to be in general conformance with AWS D1.5 2002 requirements and no relevant indications were observed. Caltrans QA Inspector performed MT and VT inspection at the locations, as mentioned above. See Caltrans Magnetic Particle Test Report, TL6028, generated on this date for additional information. The following digital picture illustrate ZPMC MT in progress.
